MATKOVICH

SOUTHBROOM
GOLF CLUB

PLANNING AND PROGRESS OF VARIOUS UPGRADES TO SOUTHBROOM GOLF COURSE

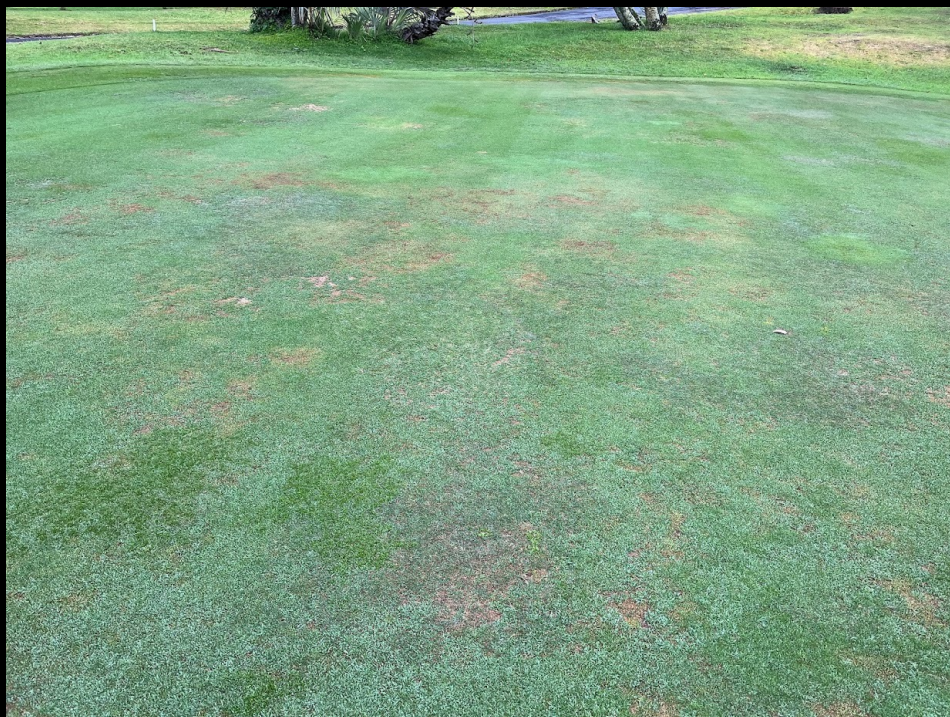
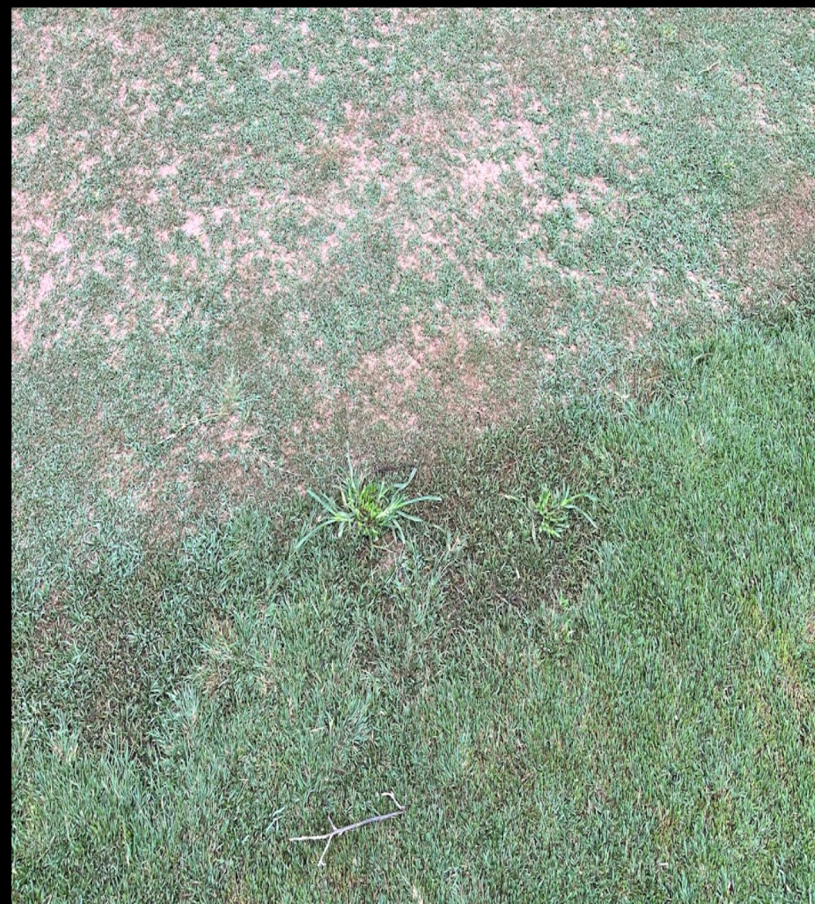
26TH JAN 2023

SOUTHBROOM GREENS CONDITION

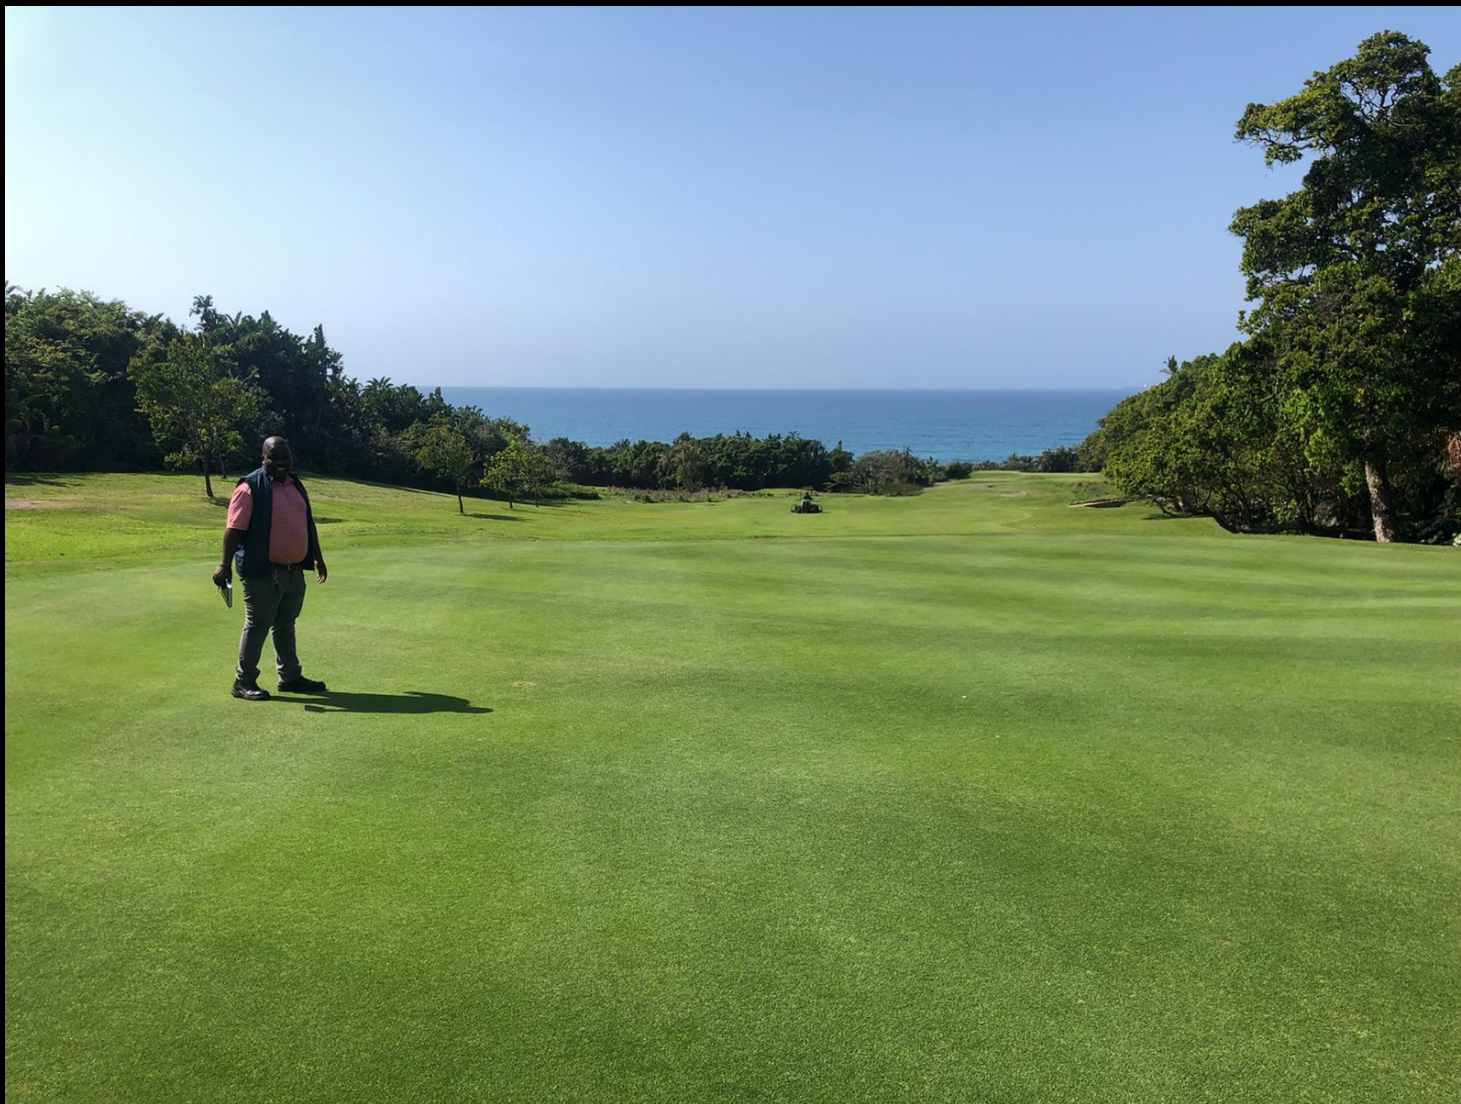
4TH OCTOBER 2023

SOUTHBROOM GREENS CONDITION

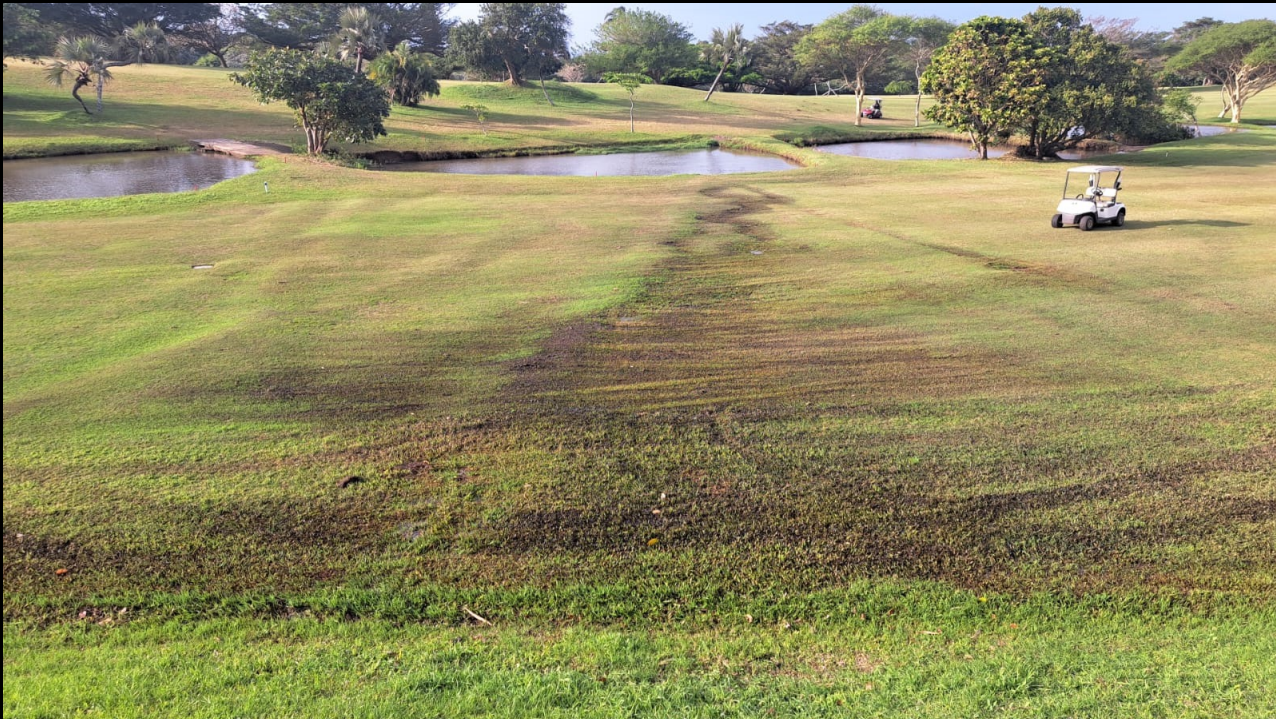
Drainage is and has been a problem at Southbroom from inception – Southbroom was built in an area that is prone to ground water seepage as well as storm water flooding.

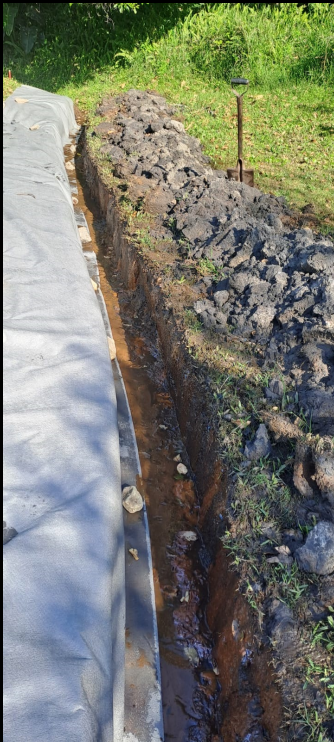
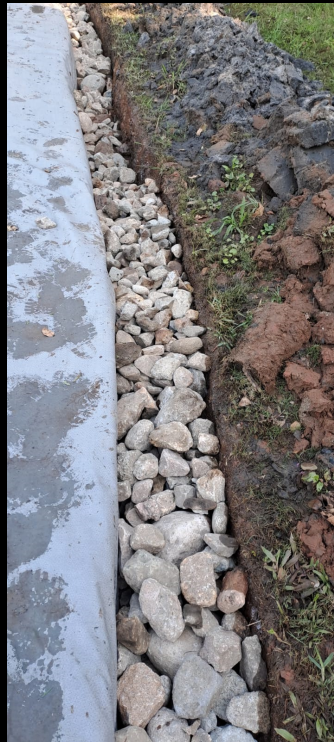
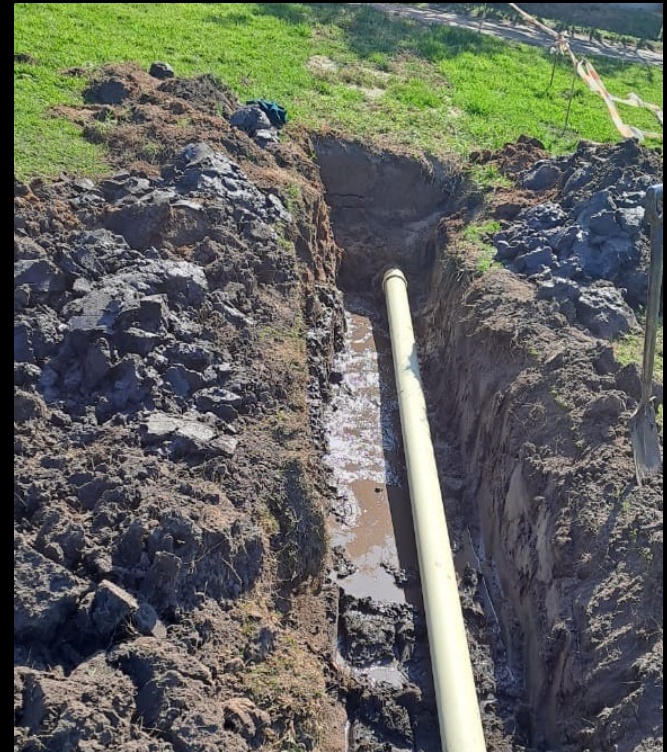
DRAINAGE

Purpose of Installation:

- Improve course conditions and playability
- Prevent waterlogging and ensure efficient water drainage
- Enhance overall aesthetics of the affected areas

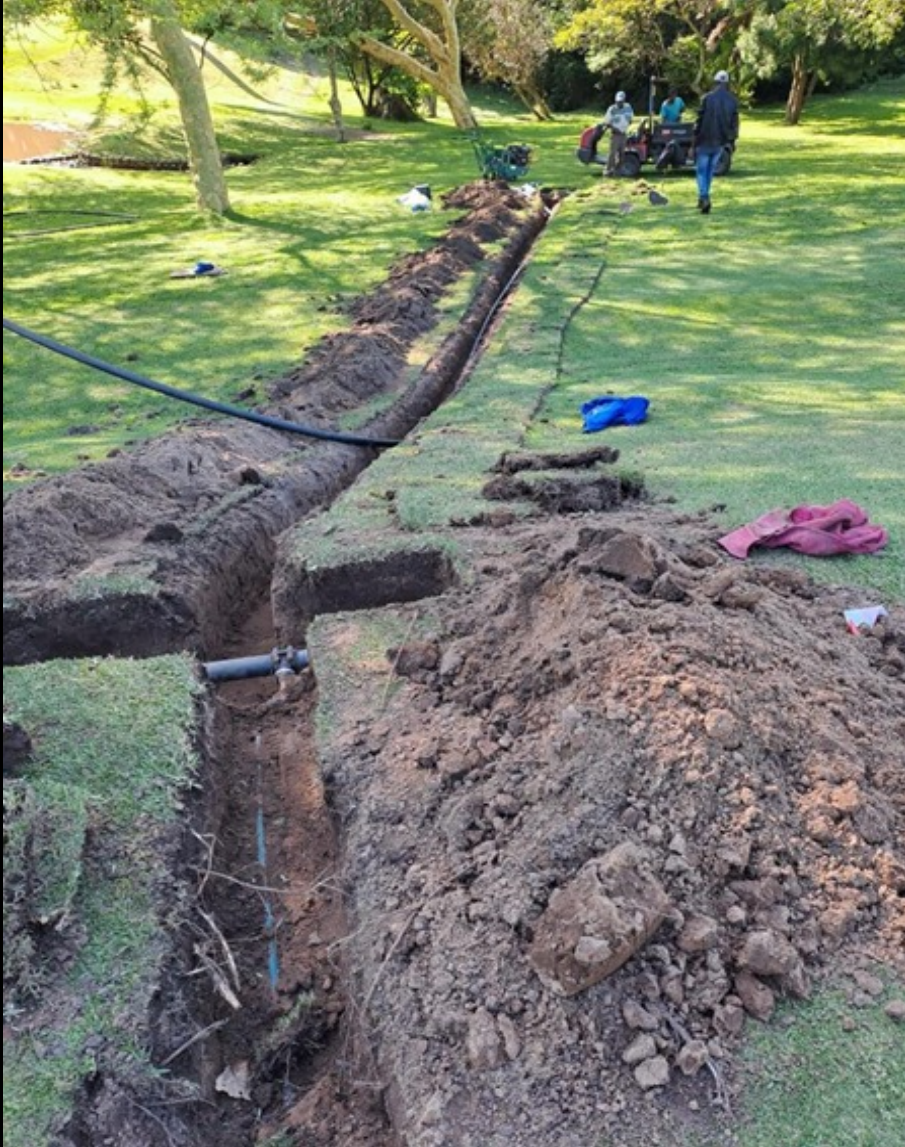
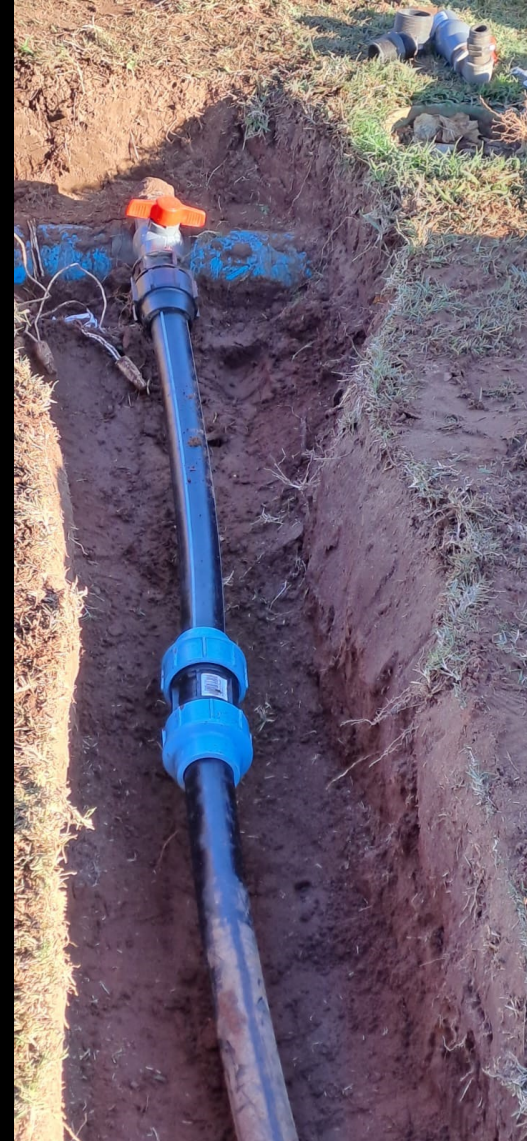
IRRIGATION INSTALATION

All green-side sprinklers were assessed. Some greens received additional heads while other green side sprinklers were either repaired or replaced. There is still a lot work to be done!

- 10th green irrigation was split for better pressure
- Turf valves installed at greens without hose connections – in progress

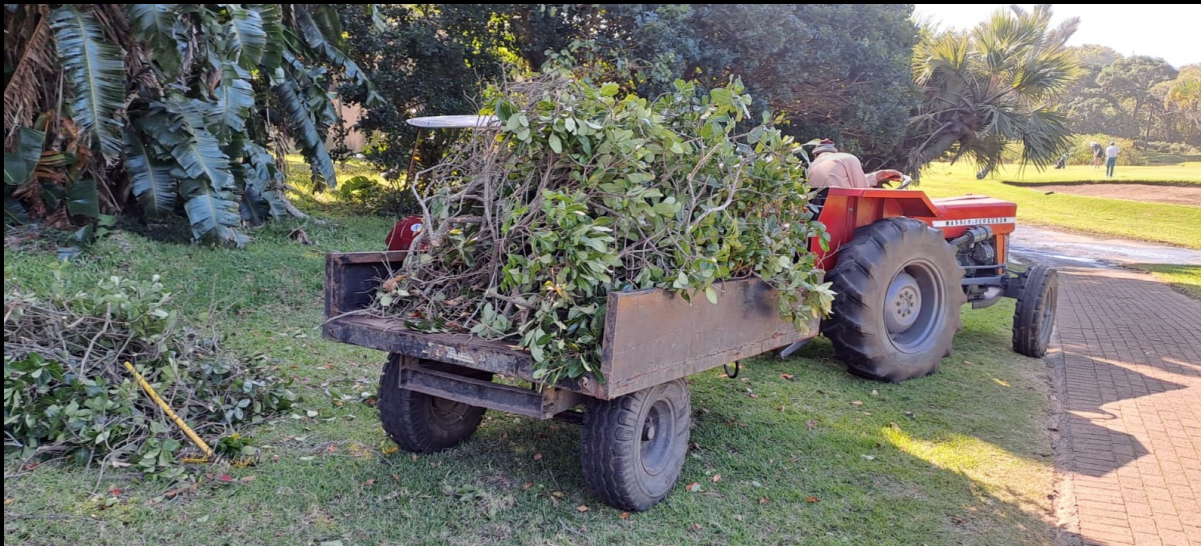
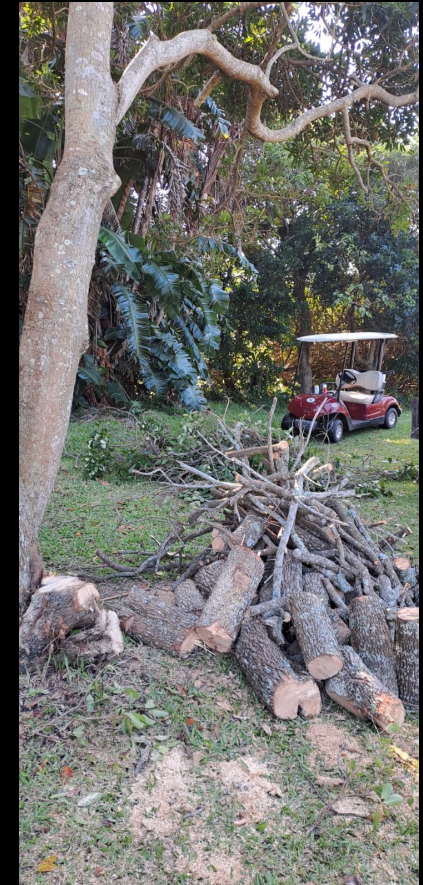
TREE PRUNING

- Clearance for structures and traffic
- Improved visibility
- Maintenance access
- Light penetration
- Aesthetic considerations

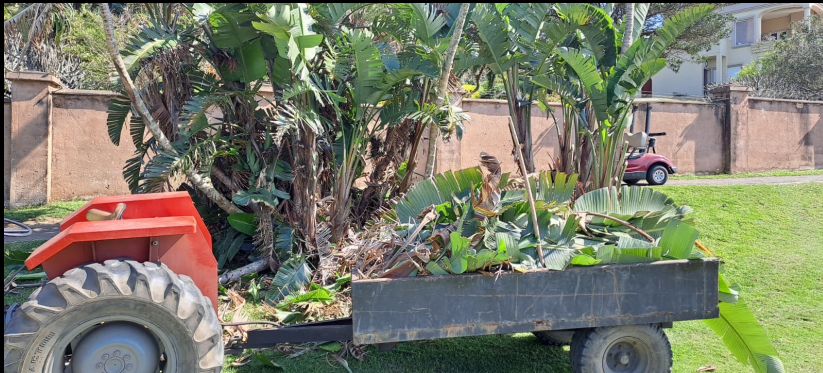
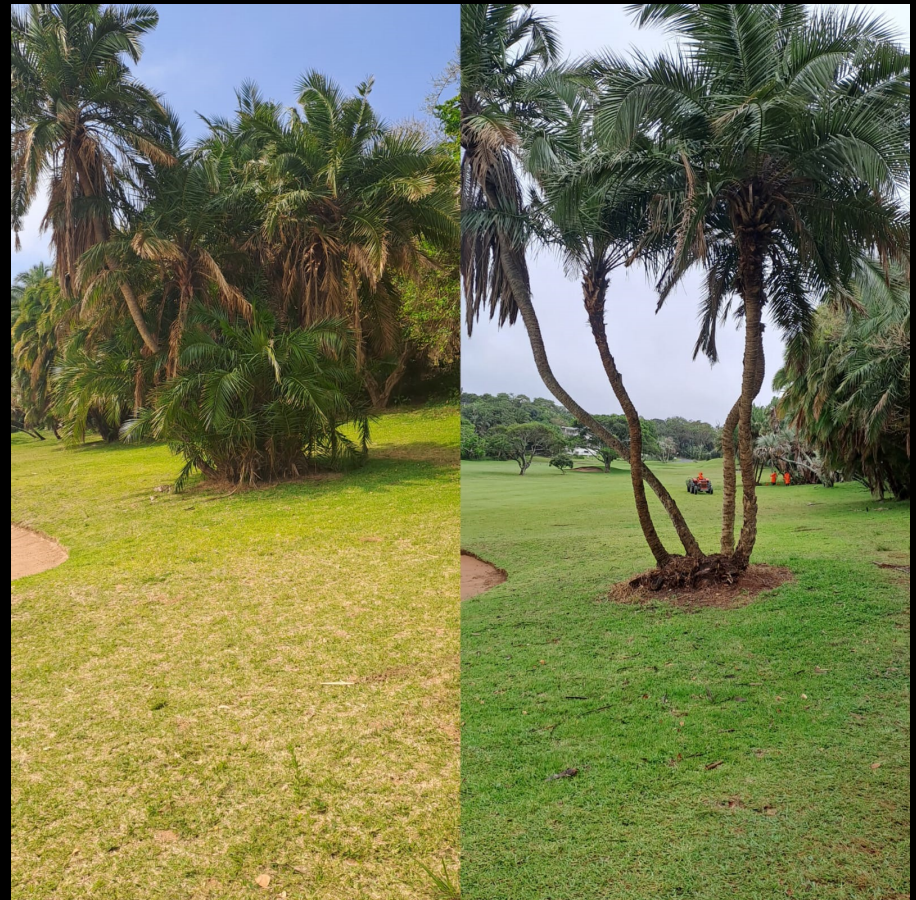
CROWN LIFTING

- Clearance for traffic
- Encourages canopy growth
- Maintenance access
- Light penetration
- Improved air circulation
